SUPERFUND SITE

NDMA PLUME MAP WITH **GROUNDWATER EXTRACTION and** TREATMENT SYSTEM **DECEMBER 2012**

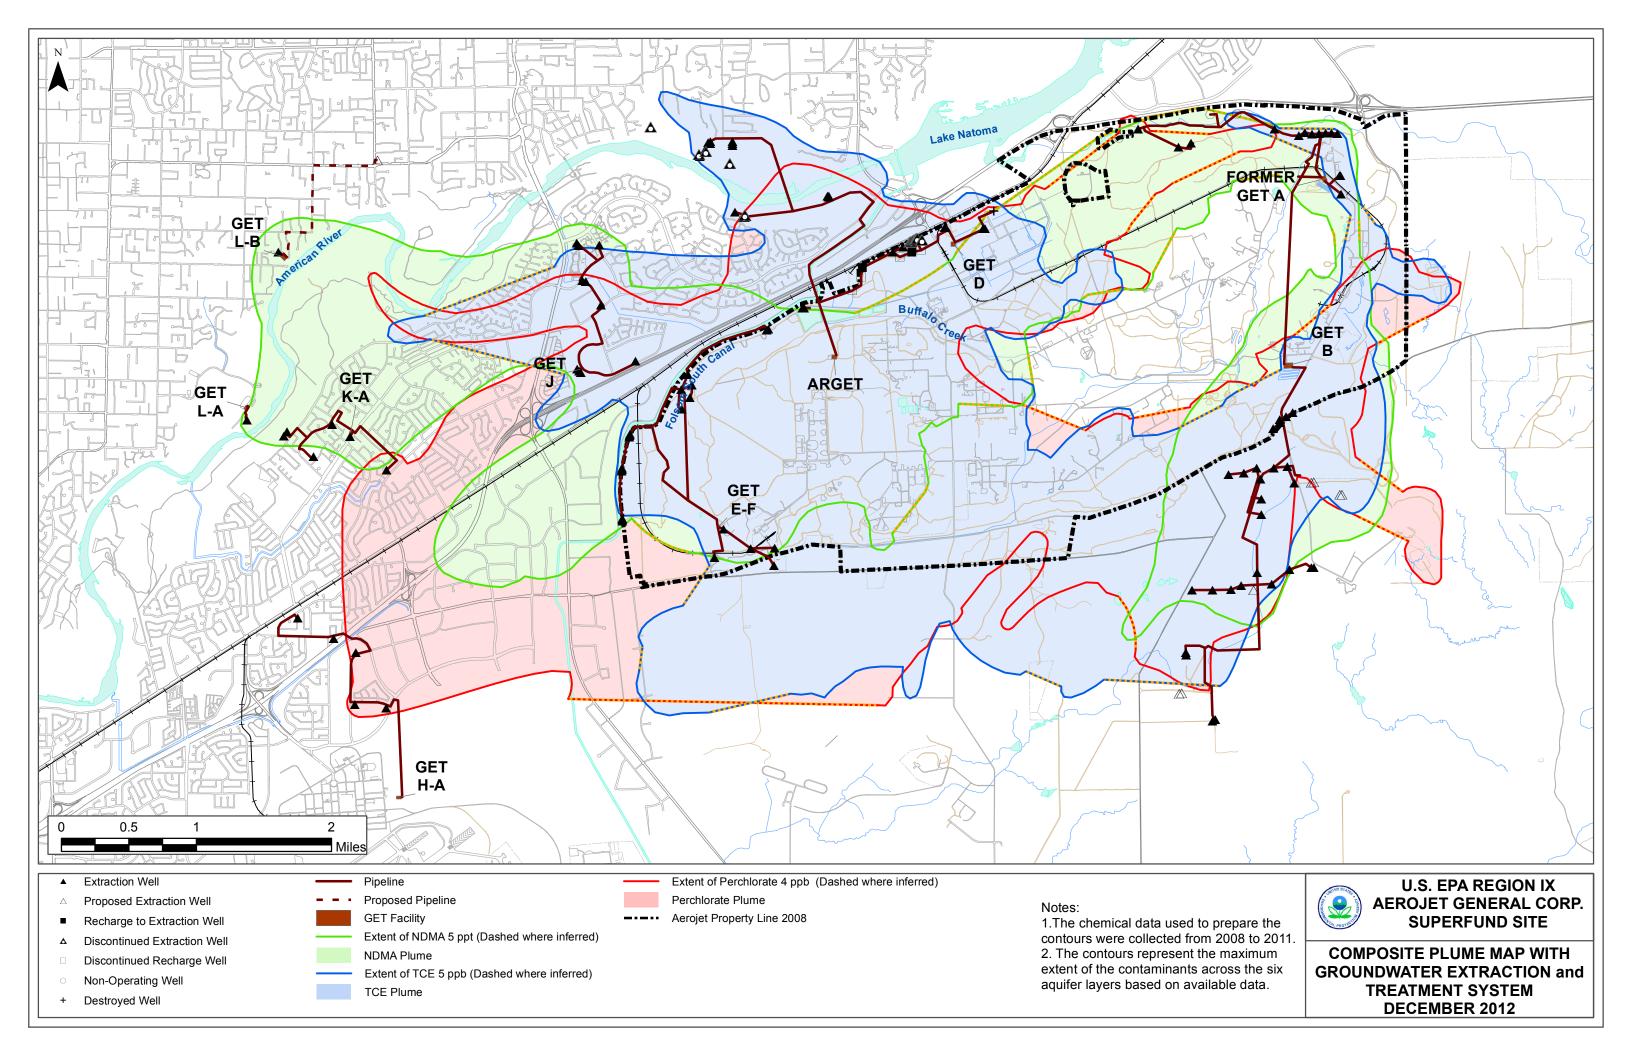
- contours were collected from 2008 to 2011. 2. The contours represent the maximum
- extent of the contaminants across the six aquifer layers based on available data.

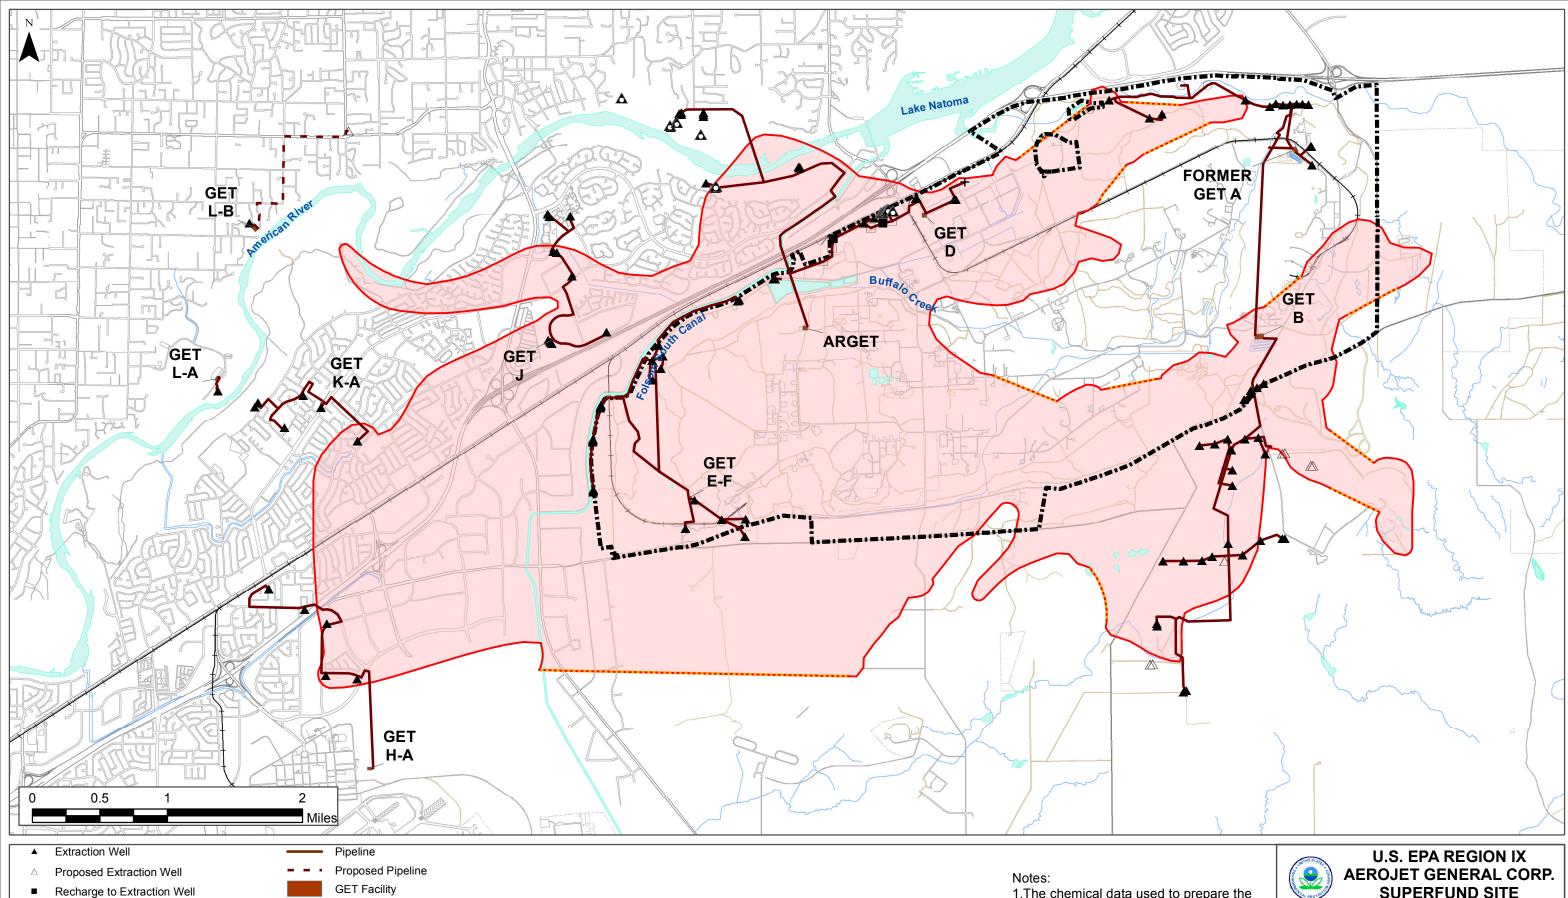
PERCHLORATE PLUME MAP WITH GROUNDWATER EXTRACTION and TREATMENT SYSTEM WITH **DECEMBER 2012**

- 1.The chemical data used to prepare the contours were collected from 2008 to 2011.
- 2. The contours represent the maximum extent of the contaminants across the six aquifer layers based on available data.

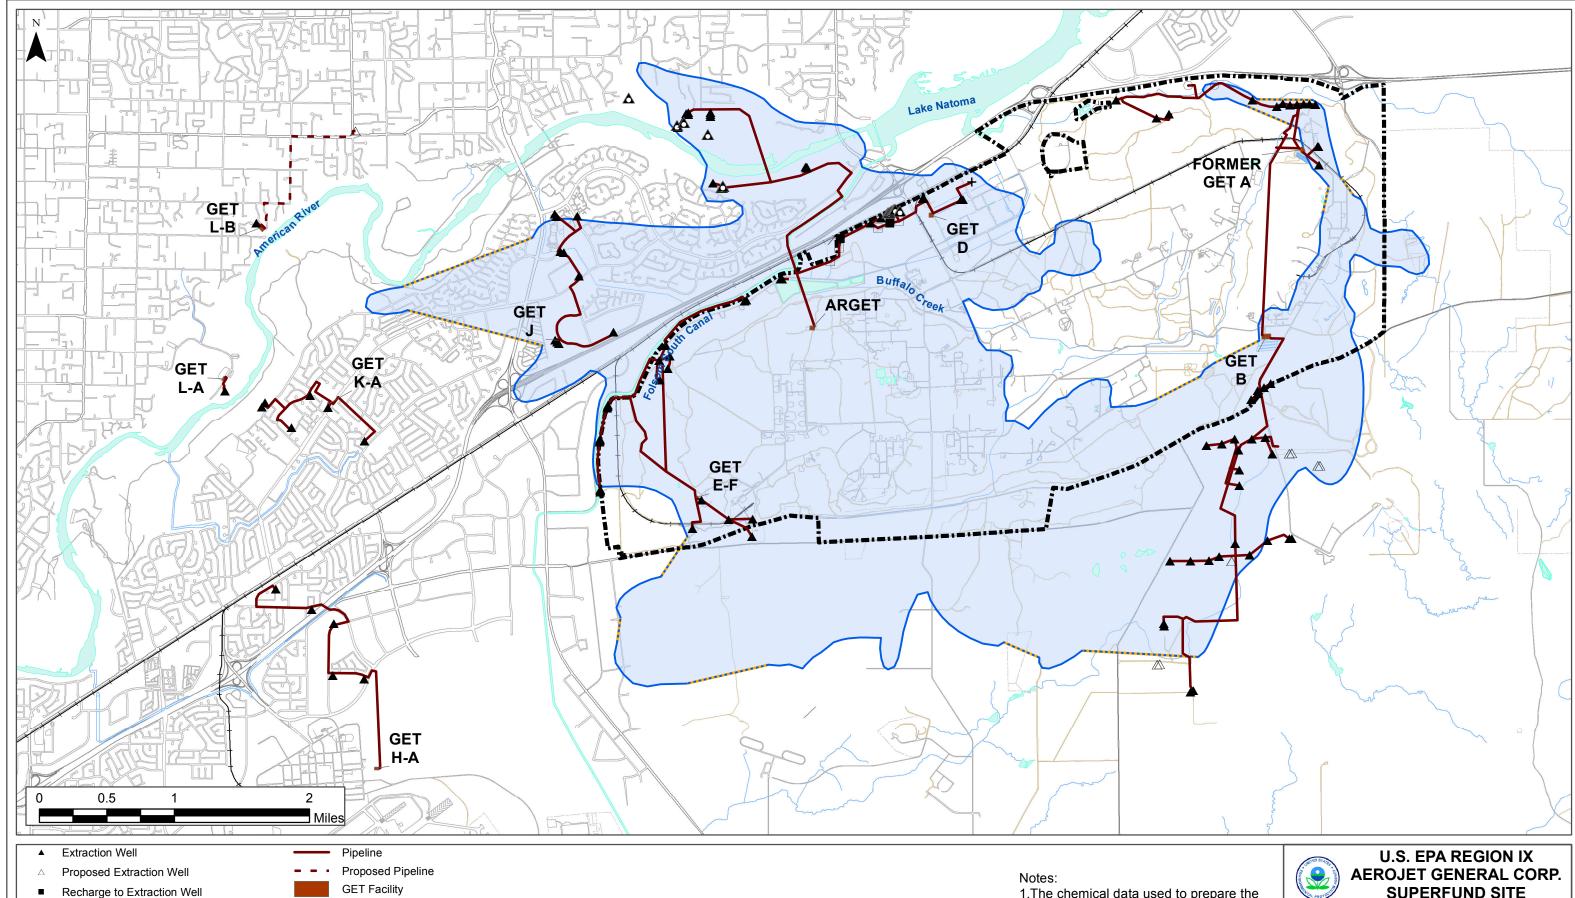
TCE PLUME MAP WITH **GROUNDWATER EXTRACTION and** TREATMENT SYSTEM **DECEMBER 2012**

- 1.The chemical data used to prepare the contours were collected from 2008 to 2011. 2. The contours represent the maximum
- extent of the contaminants across the six aquifer layers based on available data.
